ESL-TR-85-65

RAPID RUNWAY REPAIR (RRR) IN-HOUSE TEST AND EVALUATION

FINAL REPORT

ENGINEERING & SERVICES LABORATORY
AIR FORCE ENGINEERING & SERVICES CENTER
TYNDALL AIR FORCE BASE, FLORIDA 32403

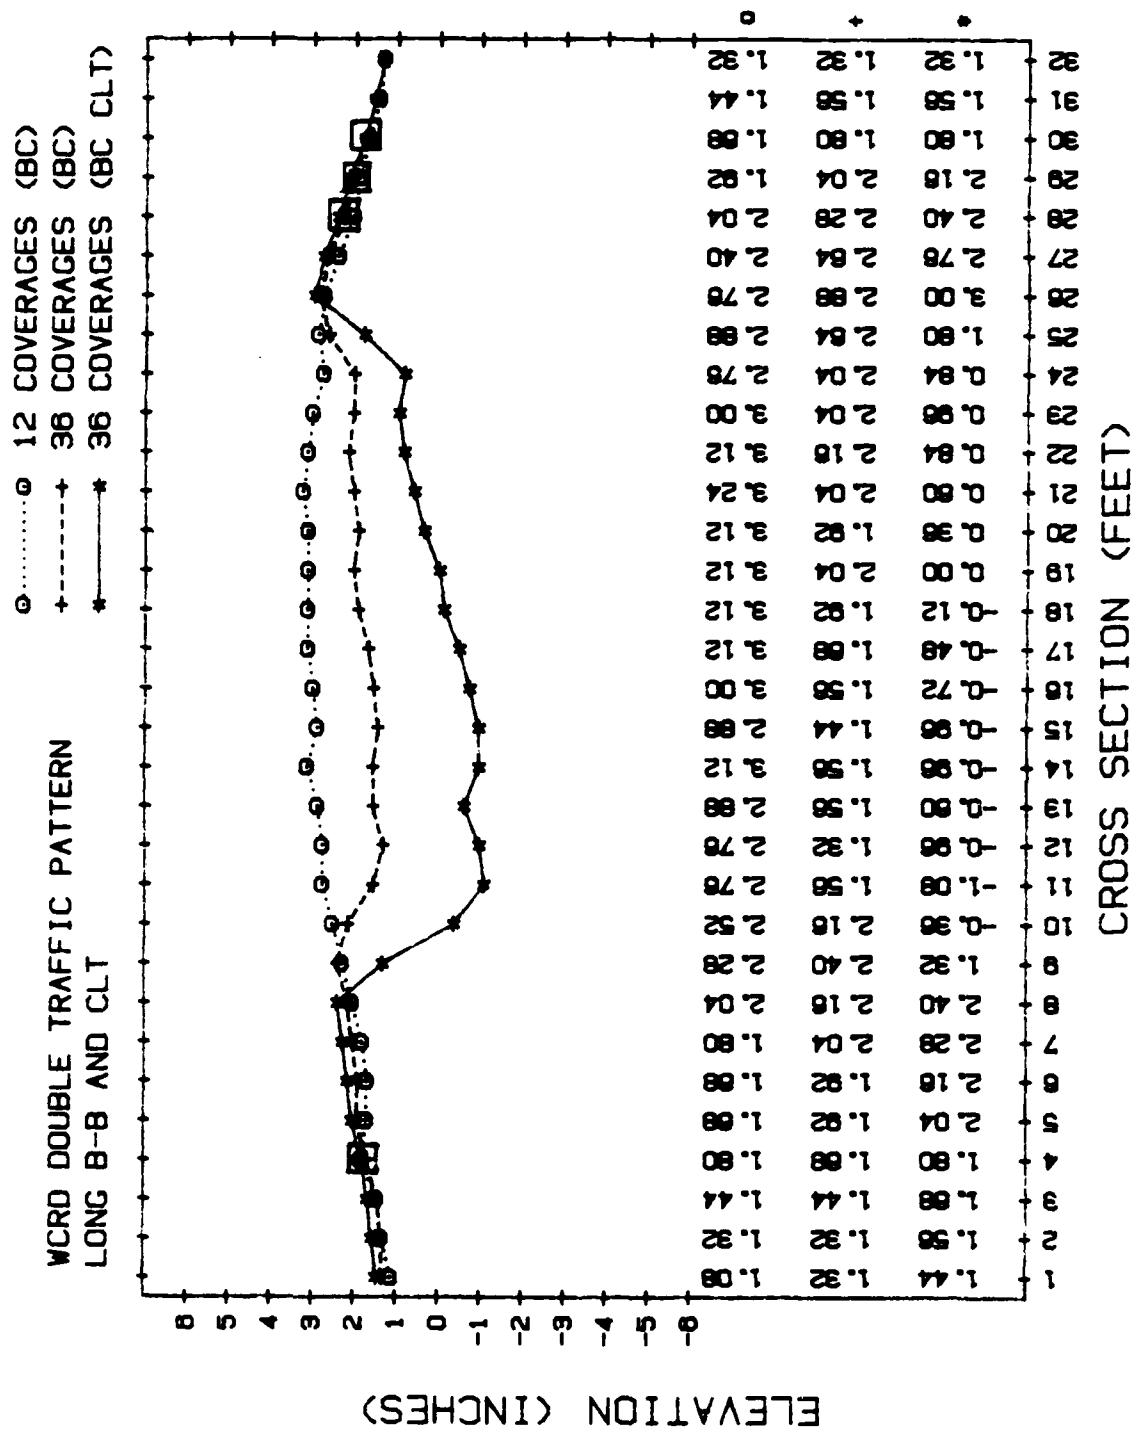
Figure 161. Base Course Elevation Profiles - Longitudinal A-A After
12 and 36 F-15 Loadcart Coverages (Second Pattern) and
Centerline of Traffic After 36 Coverages - For Wet Crater
Repair Demonstration.

Figures 160 and 161 show the longitudinal surface profiles, while Figure 162 shows the lateral surface profiles, after 12 and 36 F-15 loadcart coverages with the new pattern. Surface roughness measurements are not applicable and were not measured at the ramp (point 4, Figure 161). Also, elevation data were not recorded at points 28, 29, and 30 along longitudinal B-B after 12 loadcart coverages. When inputting data into the computer program used to plot the profiles and perform the surface roughness calculations, test analysts entered false elevations, consistent with the general profile shape, at these points (enclosed in squares) to preclude incorrect surface roughness calculations.

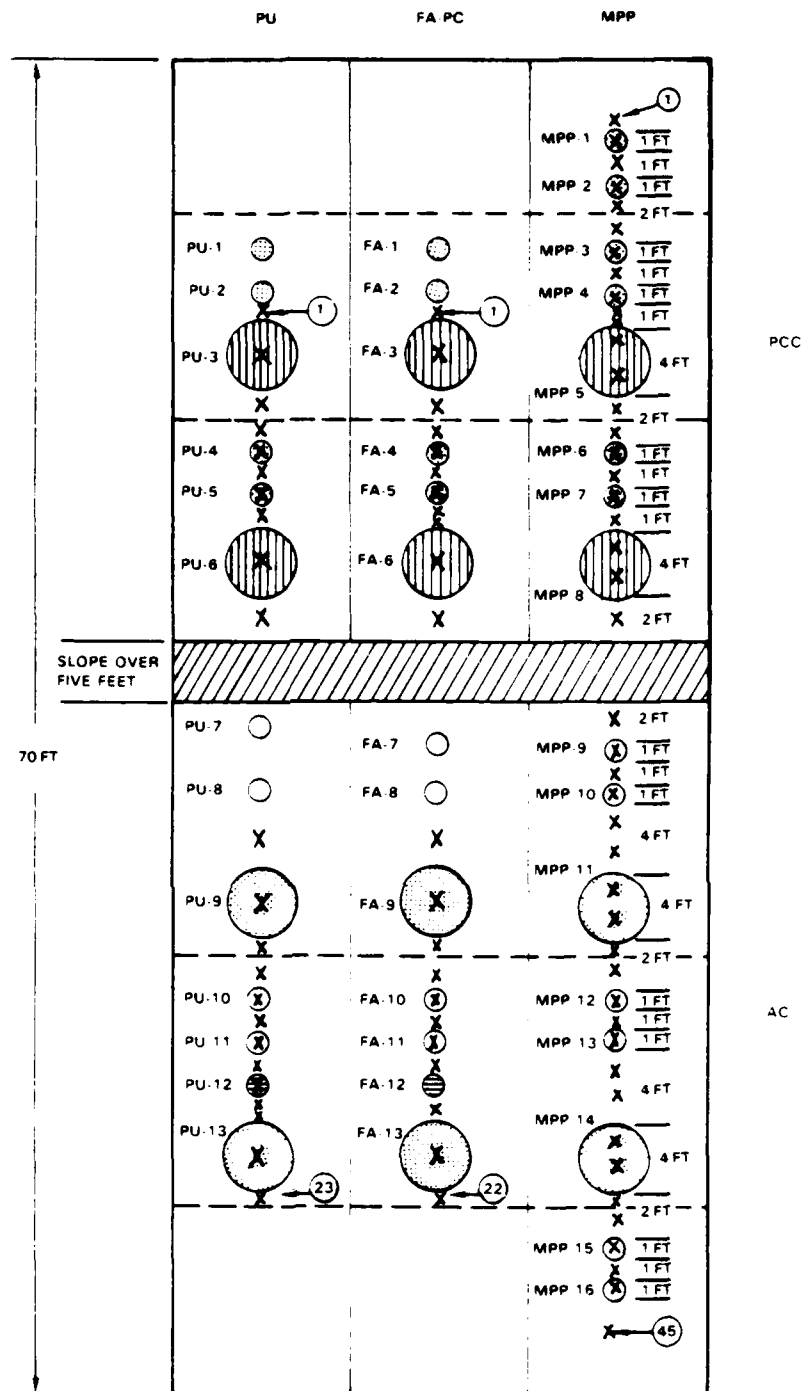
Figure 163. Plan View of Test Bed, Spall Repair with Advanced Materials.

Test personnel jackhammered 42 holes for the spall tests into the test bed at the SKY TEN facility, as shown in Figure 163, and stripped the asphalt off for spall tests in PCC pavement. Personnel formed five different types of spalls, in hemispherical and flat bottomed shapes, from 3 to 10 inches deep. The spall cross sections are presented in Figure 164.

Test personnel trafficked the repaired sections with 150 F-4 loadcart passes. Data collectors measured elevation profiles after 0, 20, and 150 passes at the positions shown in Figure 163. Personnel did not perform spall repair maintenance.

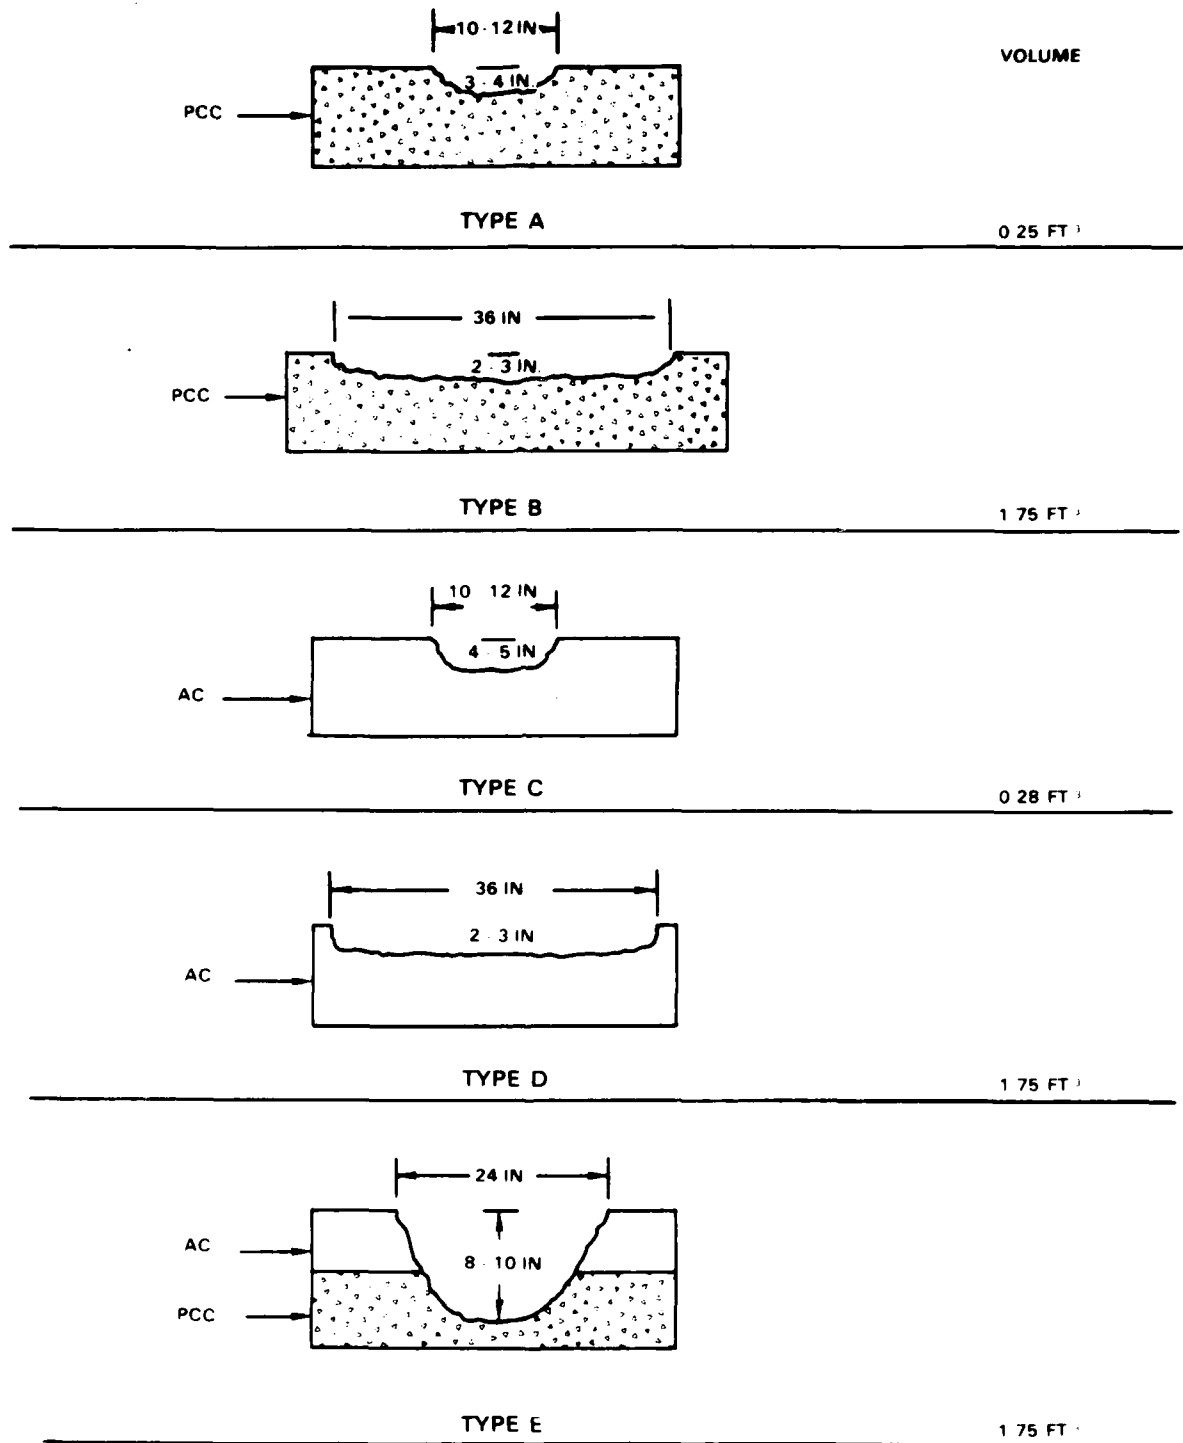
Figure 164. Cross Section of Spall Repairs, Spall Repair with Advanced Materials.

Material quantities, in cubic feet, for each type of spall repair are indicated on Figure 164. Personnel repaired 13 spalls with modified polyurethane concrete, 13 with furfuryl alcohol polymer concrete, and 16 with magnesium polyphosphate cement concrete. Table 31 summarizes of the types of spalls repaired with each concrete system and the required total volume of repair material for each material system. The components and spall repair procedures for each material system are described below.

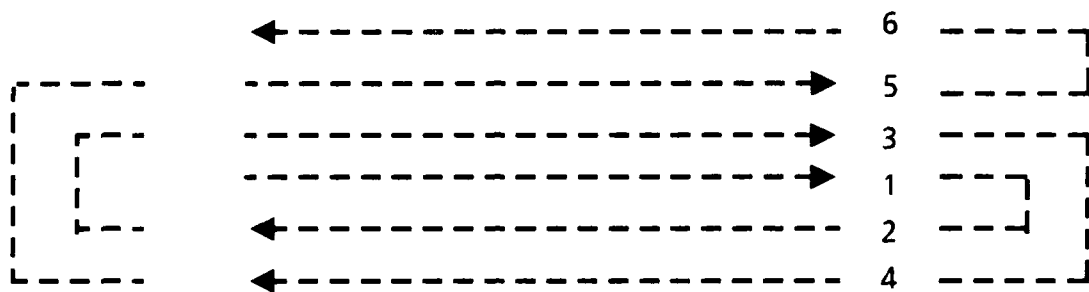
Figure 165. Pattern of Grader Passes During Multiple Spall Repair Test.

(1) Grading. The grader and all other equipment and personnel moved from the staging area on the beginning signal to the test site. The grader cleared debris by making high-speed passes over the test site following the pattern shown in Figure 165. A grader pass traverses the test site once from end to end.
